SUBJECT: *Spill Report Investigation*
Rose Chemical - Holden, Mo
FROM: Charles P. Hensley
Chief, EP&R/ENSV

TO: Ron McCutcheon, EP&R/ENSV January 17, 1986
THRU: *RS* Robert L. Sholar, Region VII TATL TAT-07-F-01334
FROM: Michael G. Clemons, Region VII TATM TDD #07-8601-05
SUBJECT: Investigation of PCB Spill at PCS #5146
Rose Chemical, Holden, Missouri

ON-SCENE PHOTOGRAPHS
ROSE CHEMICALS PCB SPILL SITE
Holden, Missouri

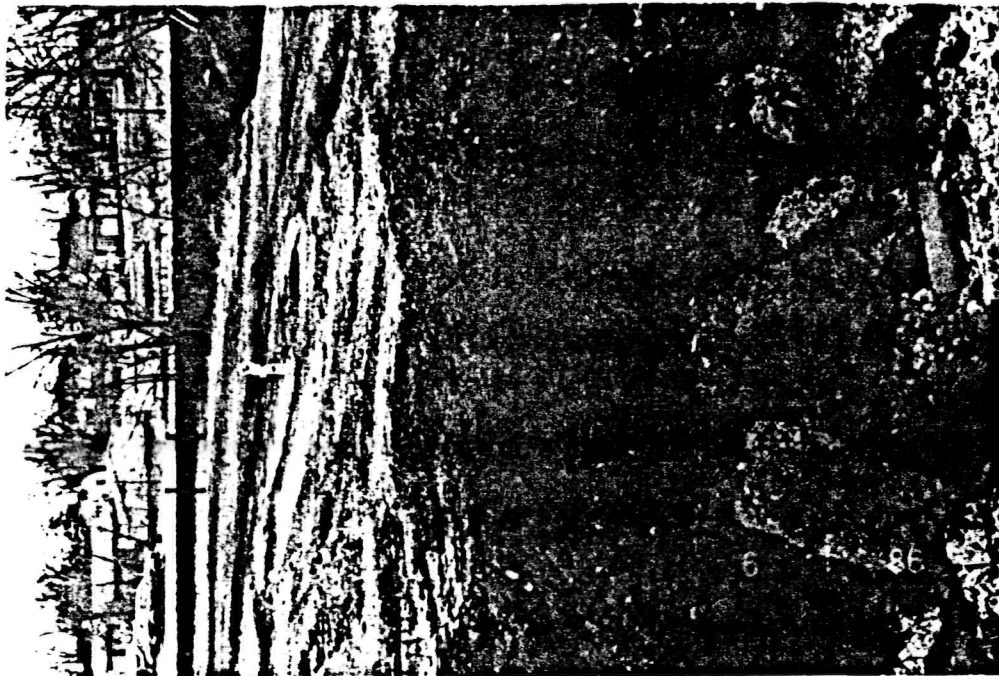
Picture #1
Date: 01/06/86
Time: 1609
Photographer: M. Castor
Witness: M. Clemons
Camera: Canon AE-1
Film: 400 ASA
Direction: S

Subject: Excavation area after PCB spill.

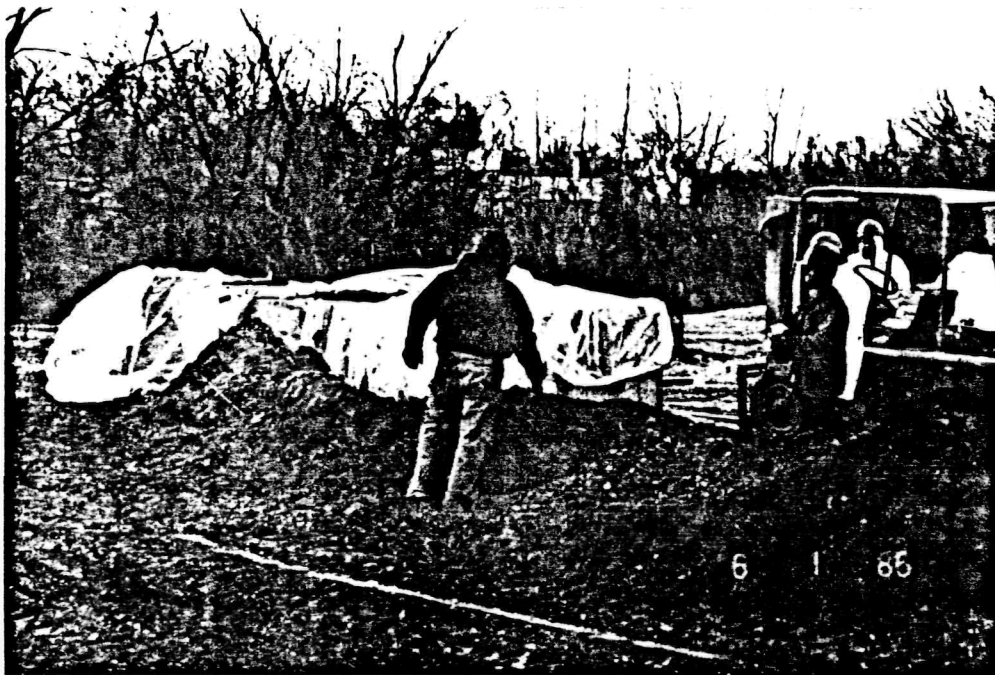
Picture #2
Date: 01/06/86
Time: 1610
Photographer: M. Castor
Witness: M. Clemons
Camera: Canon AE-1
Film: 400 ASA
Direction: W

Subject: Wooden storage bin for excavated contaminated soil.

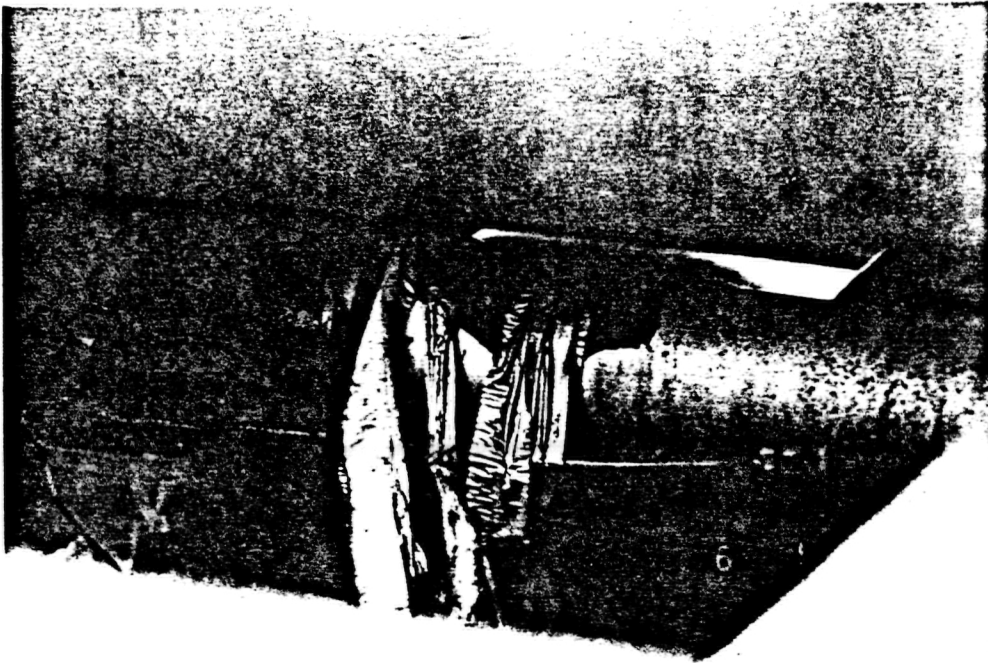
Picture #3
Date: 01/06/86
Time: 1611
Photographer: M. Castor
Witness: M. Clemons
Camera: Canon AE-1
Film: 400 ASA
Direction: N/A

A tanker truck containing PCB contaminated transformer oil had been emptied (the Rose Chemical Company has a process to detoxify PCB contaminated oil). After the tanker truck had been off-loaded, the empty tanker was parked in the graveled south parking lot. Sometime over the weekend of January 4-5, 1986, the belly drain valve on the tank truck apparently cracked, allowing the residual oil contained in the drain system to leak onto the frozen ground. When the leak was noticed on Monday morning, the tanker was transported to the dike protected off-loading bays and the cleanup of the spill area was instituted. Approximately 10-15 gallons were spilled. None of the material had reached the nearby creek on the west boundary of the plant property. Mr. Thomas anticipated excavating approximately 24 cubic yards of earth during the cleanup and either transporting the material to U.S. Ecology or ESI for disposal. Total PCBs in the oil was 126 ppm, of which 118 ppm were Arochlor 1260 and 9 ppm were Arochlor 1242.

Subject: Faulty valve on leaking tanker truck.

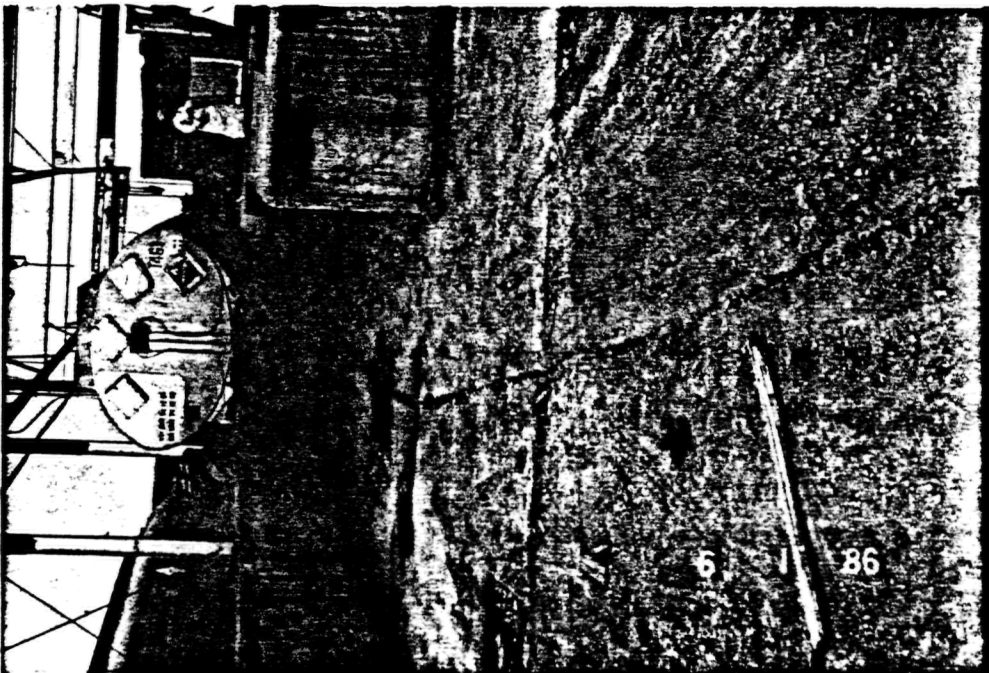
Picture #4
Date: 01/06/86
Time: 1612
Photographer: M. Castor
Witness: M. Clemons
Camera: Canon AE-1
Film: 400 ASA
Direction: N

Subject: Leaking tanker in offloading bay and drip trail.
